RARITAN RIVER BASIN
SOUTH BRANCH OF RARITAN RIVER
HUNTERDON COUNTY
NEW JERSEY

CLINTON MILLS DAM

NJ 00122

**PHASE 1 INSPECTION REPORT
NATIONAL DAM SAFETY PROGRAM**

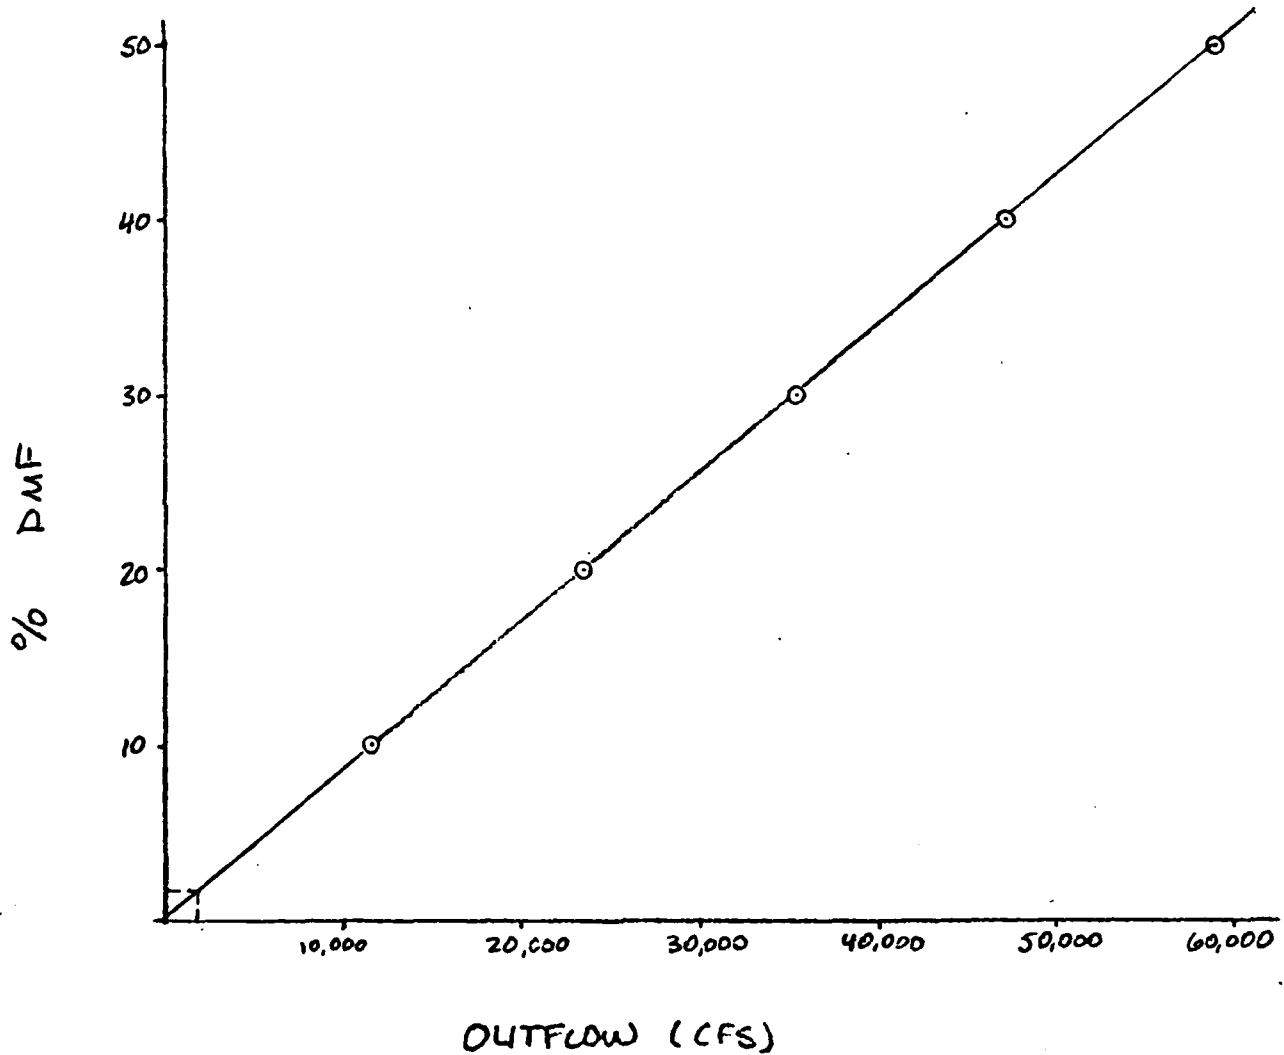
OVERTOPPING POTENTIAL

OVERTOPPING OF THE DAM OCCURS AT ELEVATION

190.3 WITH $Q = 1906$ CFS \therefore DAM CAN PASS
